PROCEEDINGS  
OF THE  
SMRM DEGRADATION STUDY WORKSHOP

Organized by:  
The Satellite Servicing Project  
Goddard Space Flight Center

May 9-10, 1985

**SUMMARY OF THE SMRM DEGRADATION  
STUDY WORKSHOP**

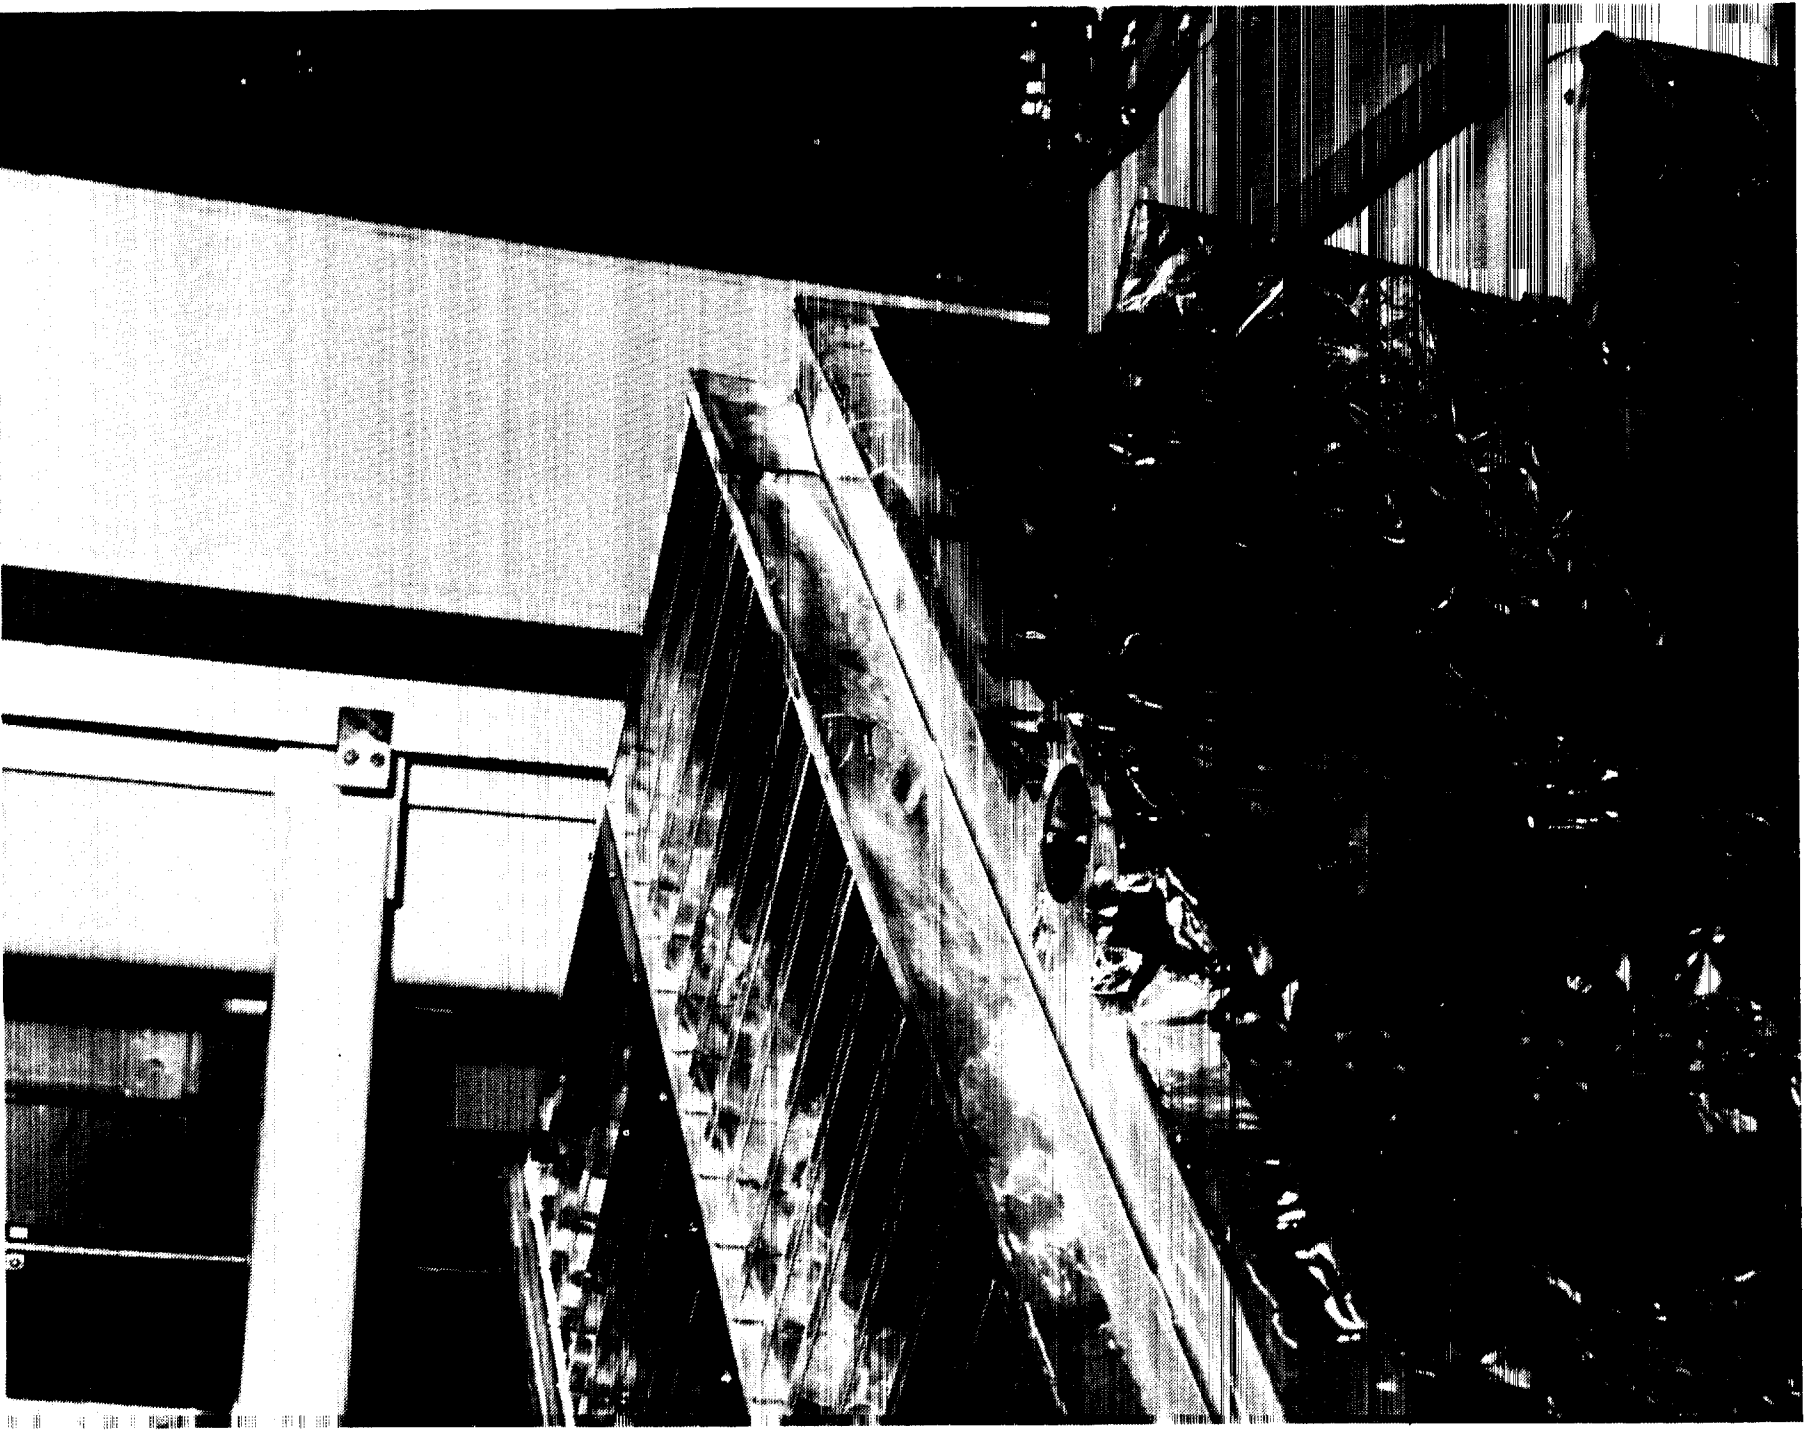
View of “top” (Sun-facing side) of MACS. Discoloration and tearing of silver Teflon, and fading of Kapton, are seen on the corner exposed to solar radiation.

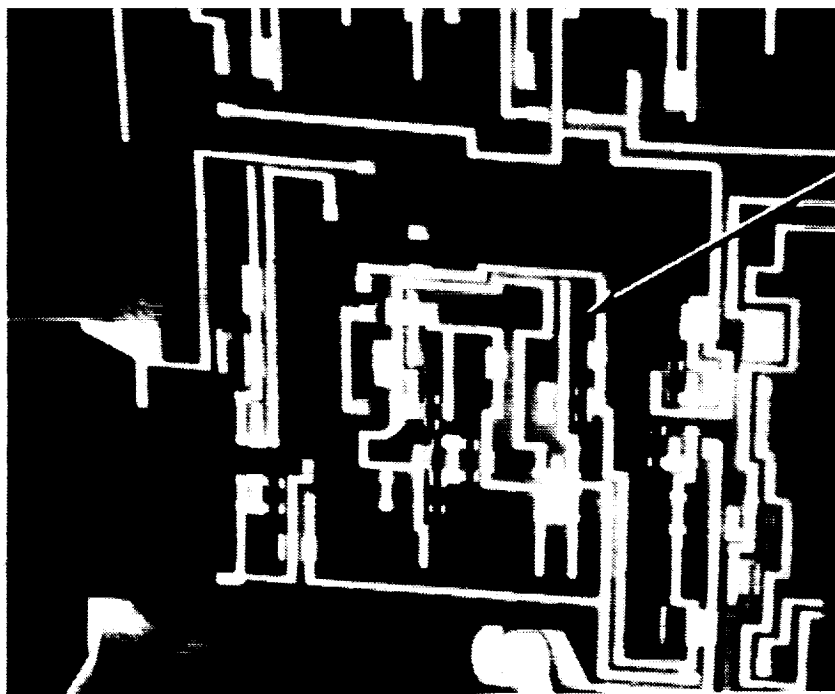
Output-0 volts  
not correct.

Figure 1. Photomicrograph of failed counter stage. (Light areas indicate zero volts. Dark indicates  $V_{DD}$ ).

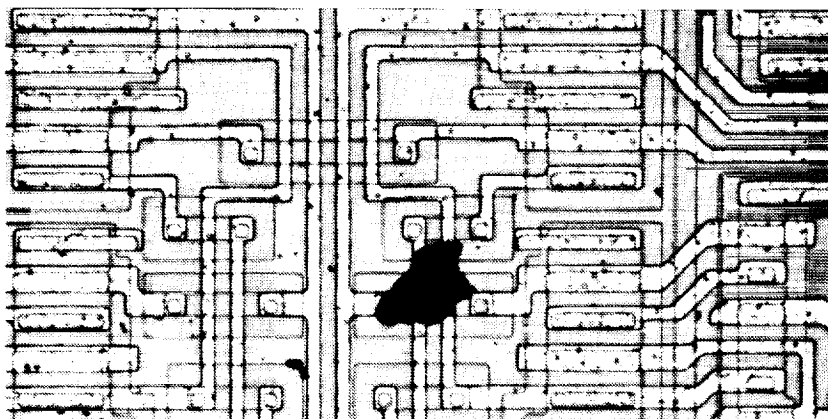
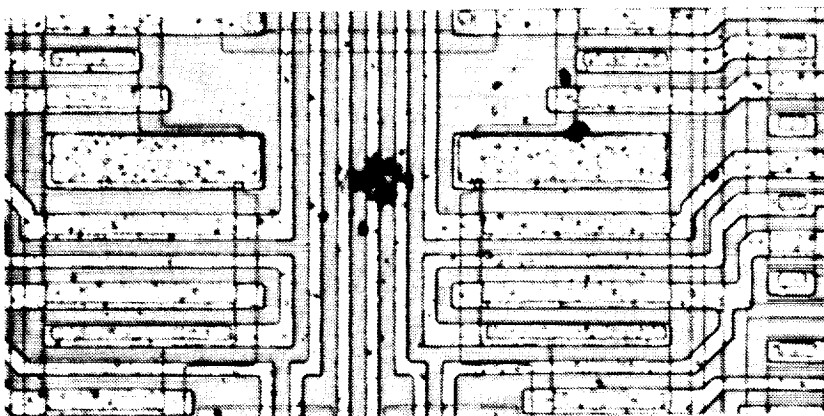
Fig. 1. Photomicrographs of die surface contamination (SN 139)

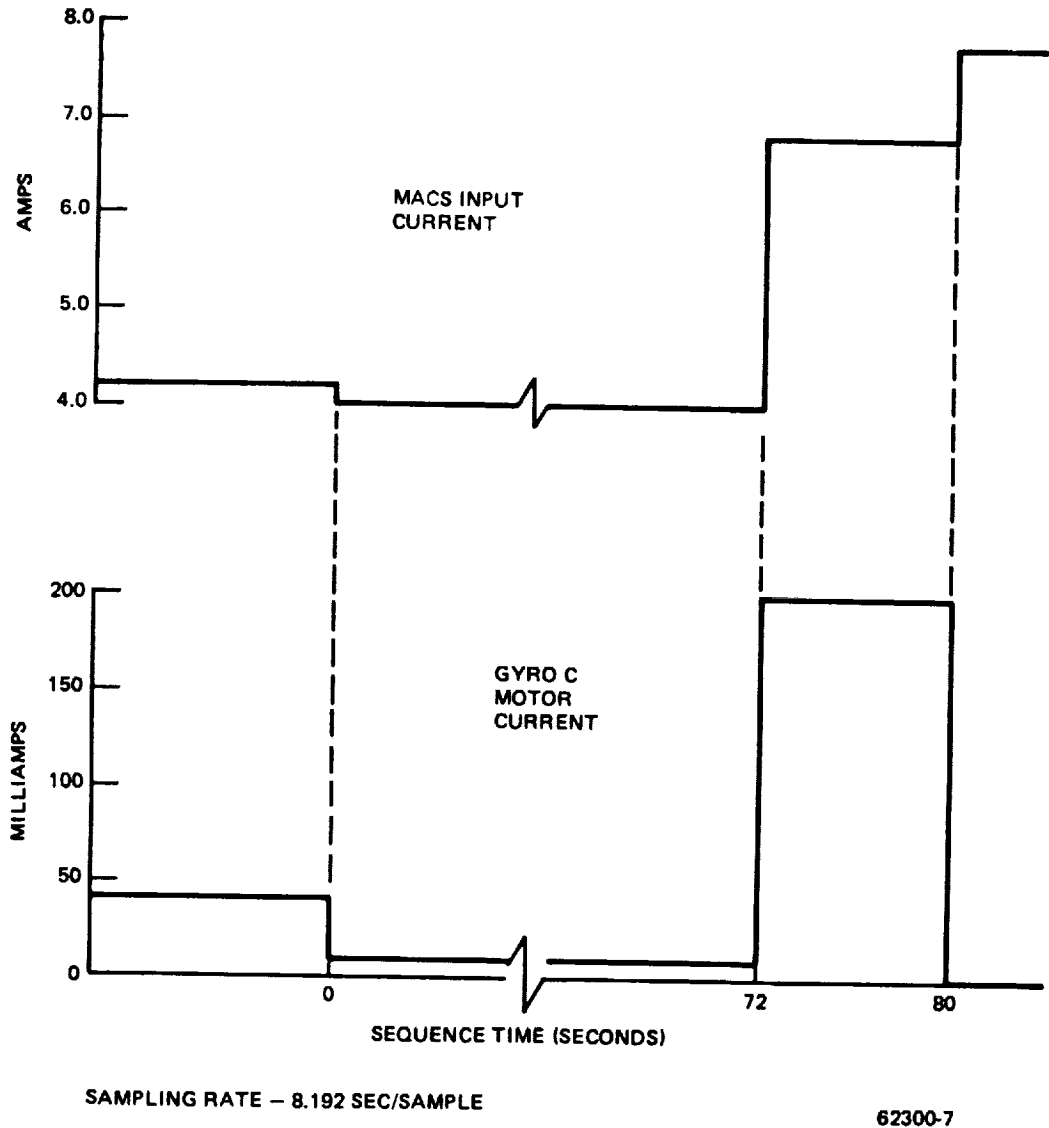
Figure 5. Failure Telemetry Data

Based on these symptoms, a failure tree was created and failure analysis reports were generated by GSFC,<sup>4</sup> JPL<sup>5</sup> and Teledyne. The reports were in general agreement that the failure was most probably in the motor control logic. This conclusion was verified by troubleshooting after SMM retrieval.

In the immediate aftermath of the failure, much effort was expended to determine if the failure could have been induced by radiation. This was required because the failure occurred while in the vicinity of the South Atlantic Anomaly and was nearly coincident with unrelated memory

failures elsewhere in the spacecraft that were determined to be radiation induced. Also, the suspect logic devices were CMOS, which were considered potentially sensitive to radiation. Extensive tests were performed which eventually led to the conclusion that radiation was not a probable cause of the failure. This conclusion was also verified by troubleshooting after retrieval.

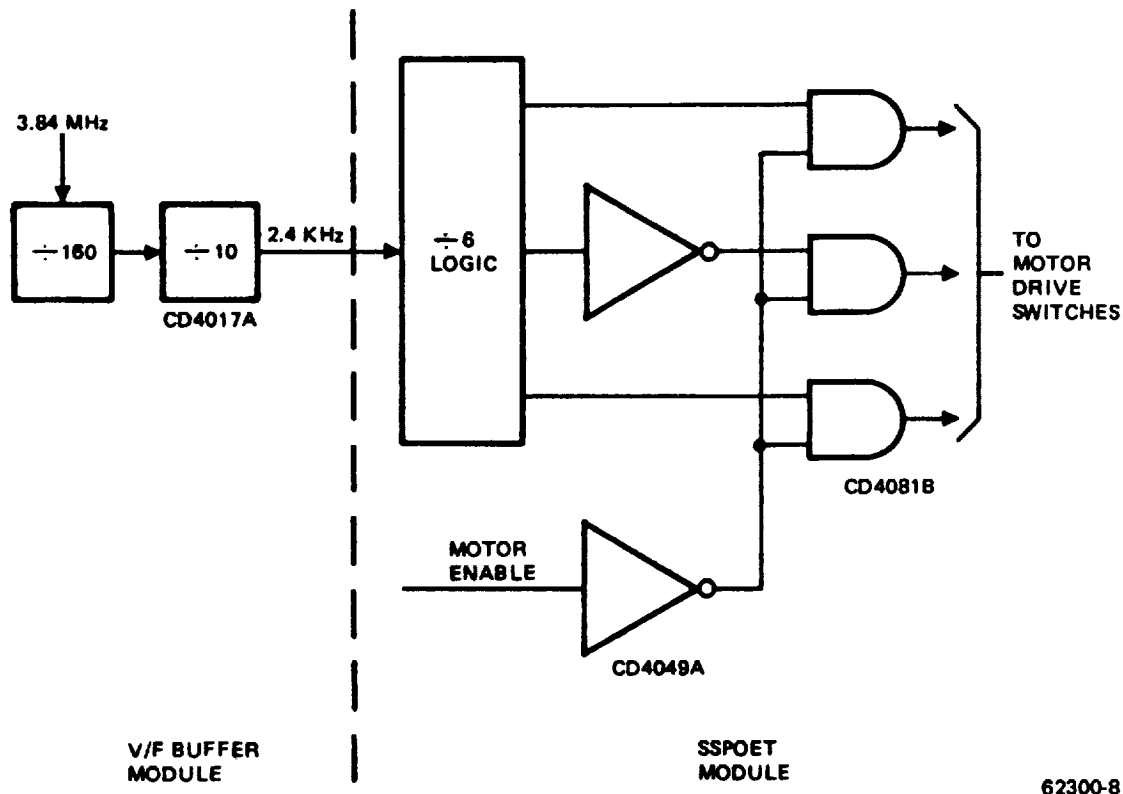
Figure 6. DRIRU II Motor Control Logic

The three failed logic devices were returned to GSFC for failure analysis.<sup>6</sup> The CD4049A and CD4081B exhibited obvious electrical overstress. The CD4049A had a fused output, which, at the system level, serves as an input to three pins of the CD4081B. The observed electrical overstress and the +5 volt out of tolerance condition are compatible with the application of a voltage greater than 8 volts to this node. The CD4017A did not exhibit physical signs of induced overstress but appeared to have an oxide defect that caused a resistive short between an internal die signal and ground. No scenario has been developed to relate all of the observed orbital failure symptoms solely to the defective CD4017A device. However, because the data gathered during troubleshooting indicates with a high degree of certainty that the failure was characterized by an out of tolerance logic supply voltage, it follows that the latent defect in the CD4017A could have been the most susceptible weak link. With the combination of CD4017A and CD4049A failures, all of the orbital failure symptoms have been reproduced in the laboratory.

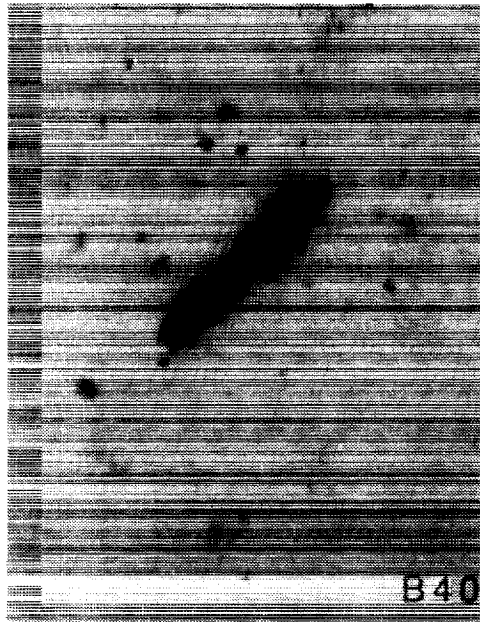
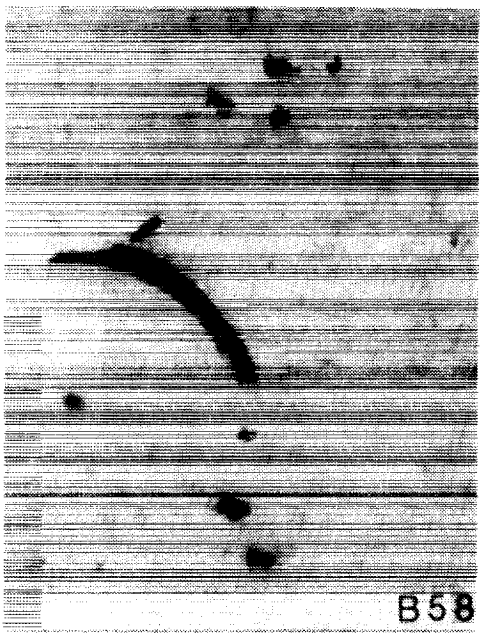
Figure 5. Typical particles collected off of B40, top, and B58, bottom.  $56\times$ .

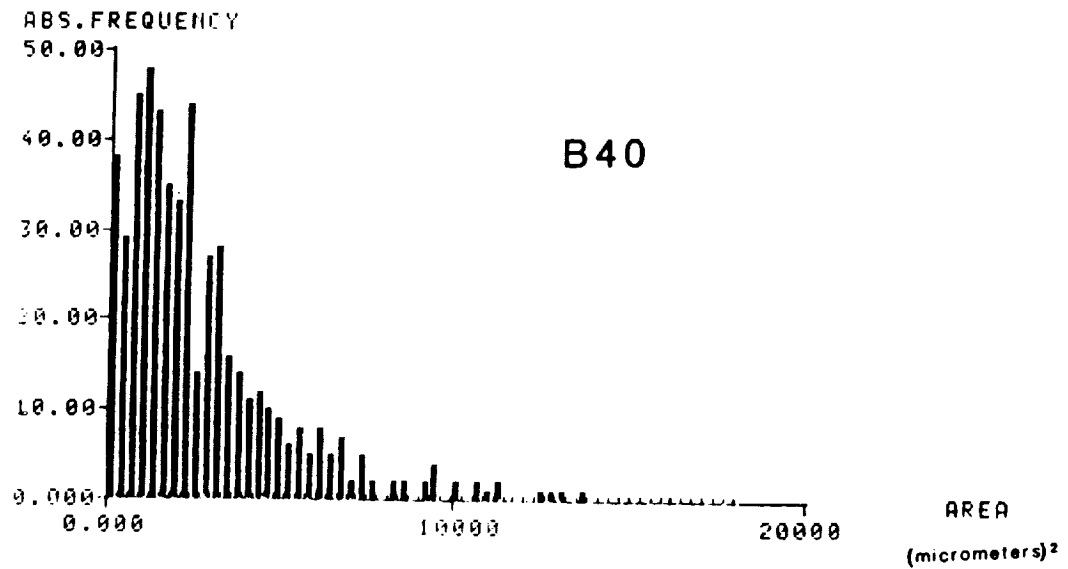
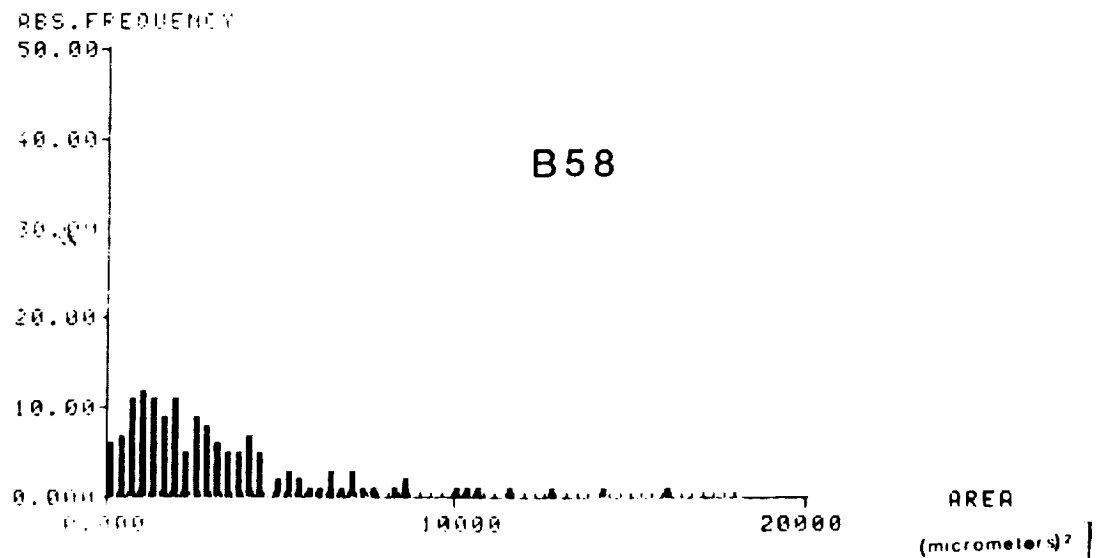
Figure 6. Histograms of particle count of debris--B40, top graph, and B58, bottom graph.

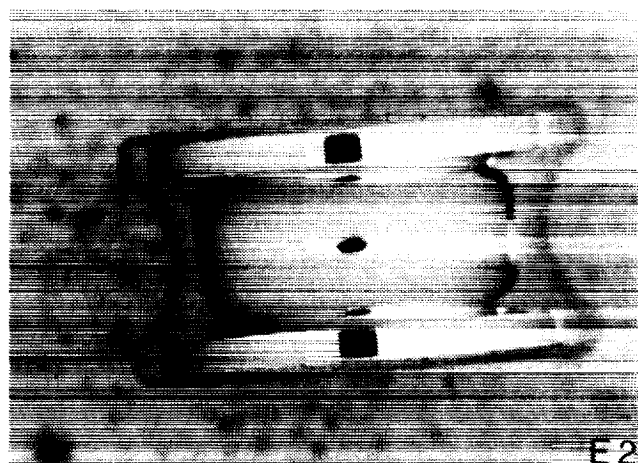
Figure 8. Inner races of bearings—top to bottom—E2, B40, B58. Note double wear tracks indicated by arrows on B40 and B58. 7.5 $\times$ .

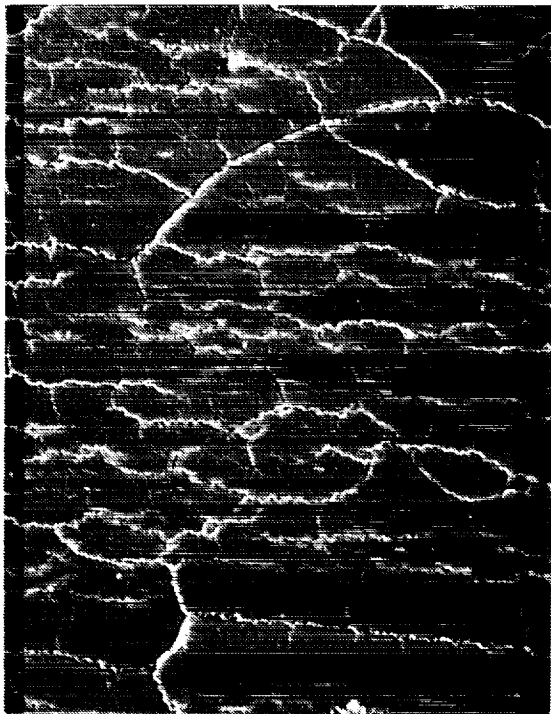
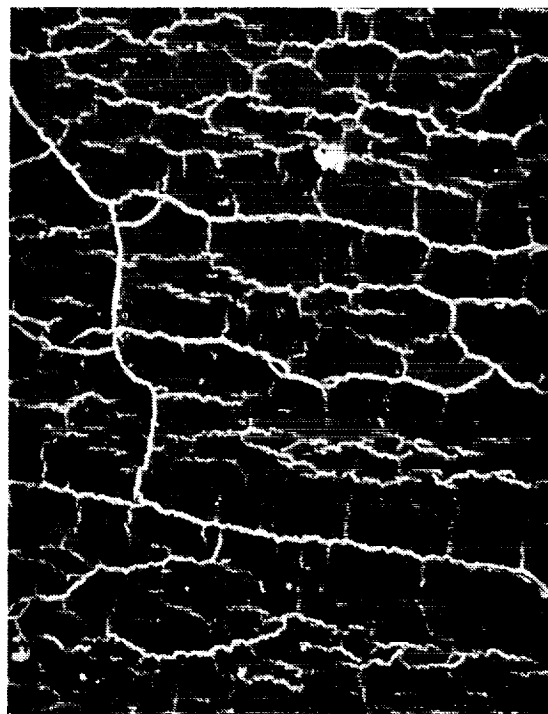
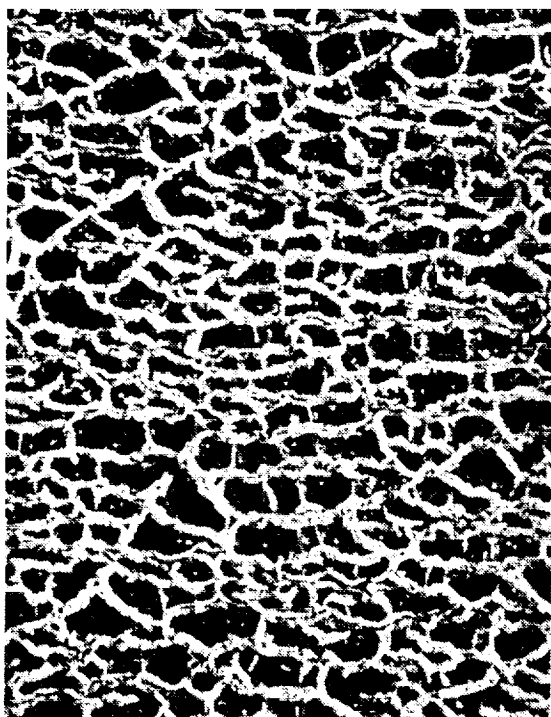
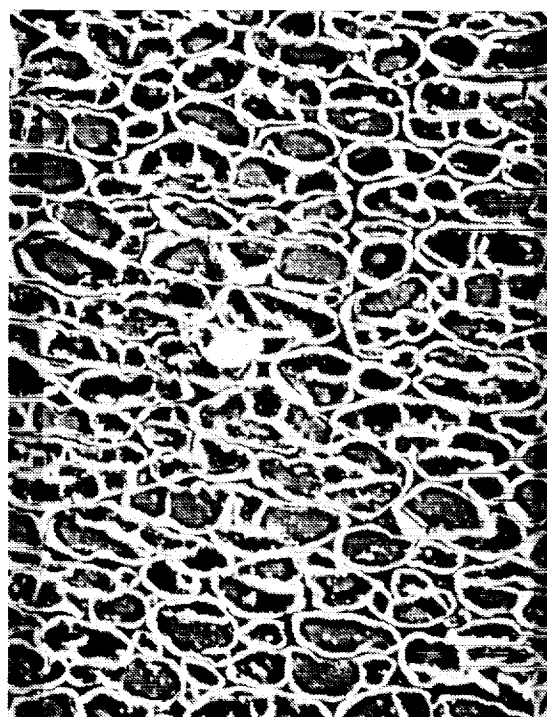
Figure 3. Scanning Electron Microscope images of Inconel surface, showing "grain boundaries" of  $\text{Ag}_2\text{O}$ .

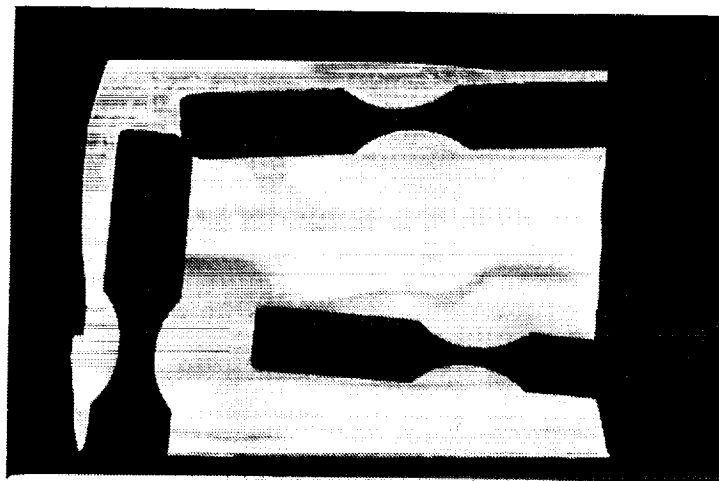
Figure 4. Silver/Teflon showing areas die-cut for tensile testing. Note right hand edge, which was one actual separation in the film.

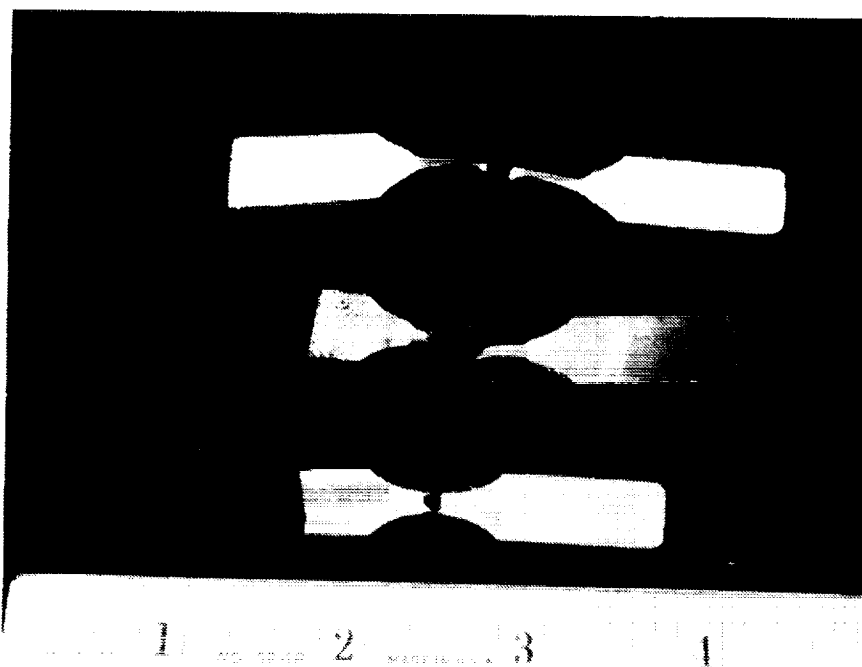
Figure 5. Tensile specimens from the ACS silver/Teflon, showing differences in elongation at room temperature.

Figures 5 and 6 demonstrate the differences in elongation and the break of the Black sample indicates a possible reason for the separation in the exposed silver/Teflon film. Note that the Black and the Half/Half were cut to be 90° different in orientation in the eroded area. Thus, the abrupt failure of the Black is in the direction that the film actually separated. Thus, thermal change and the resultant expansion and shrinkage would apply a tension load in the same direction as for the Black specimen tensile test. The very low elongation for this film, at room temperature, indicates that the eroded areas have no ductility even though the 1.1 lb breaking load is the same as that for the Half/Half specimen.

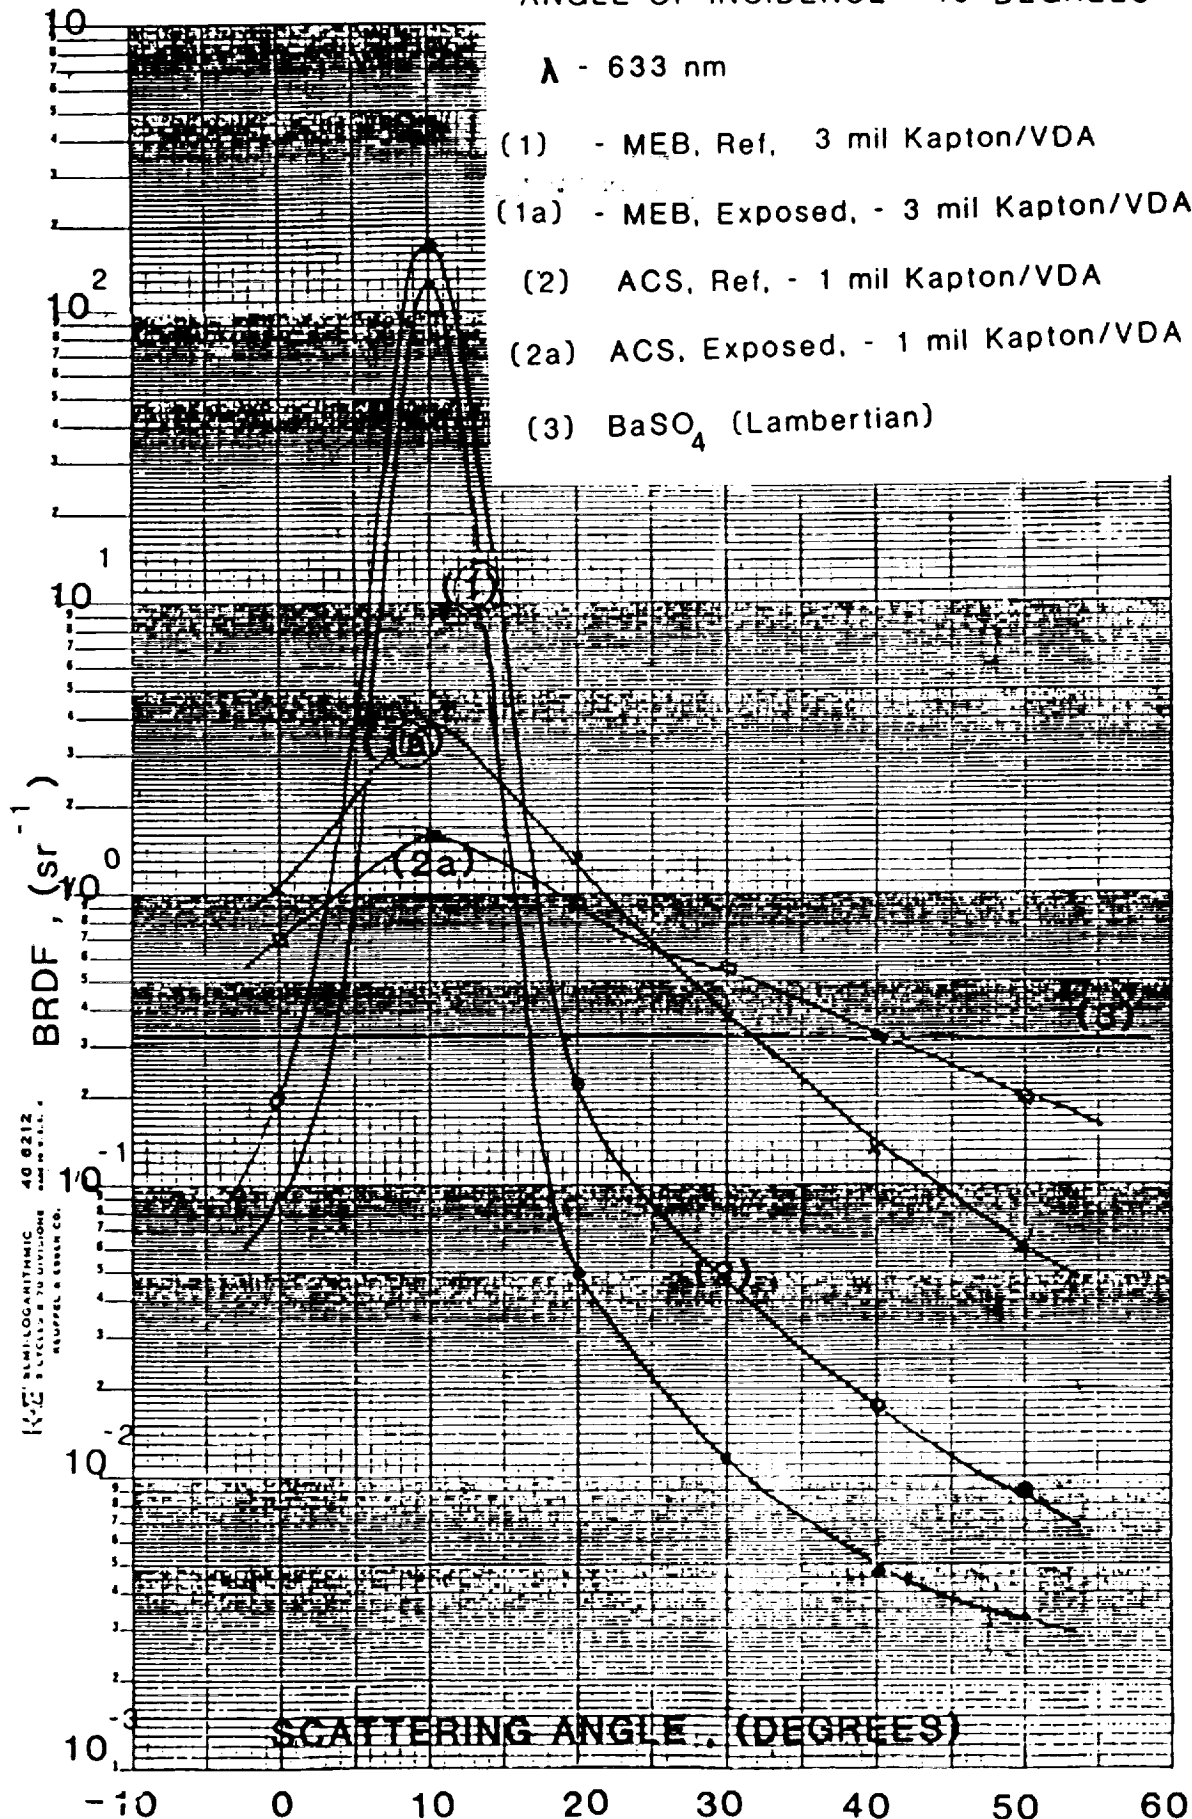
The change in the Kapton surface can be demonstrated by measurements for the Bidirectional Reflectance Distribution Function. The enclosed graph, Figure 8, shows the comparisons of the MEB Kapton and the ACS Kapton with the standard barium sulfate surface. As demonstrated in the graph, the changes due to the space exposure result in a diffuse surface, as can be observed visually, also.

Figure 8. Bidirectional Reflectance Distribution Function Data for Exposed Kapton Film.

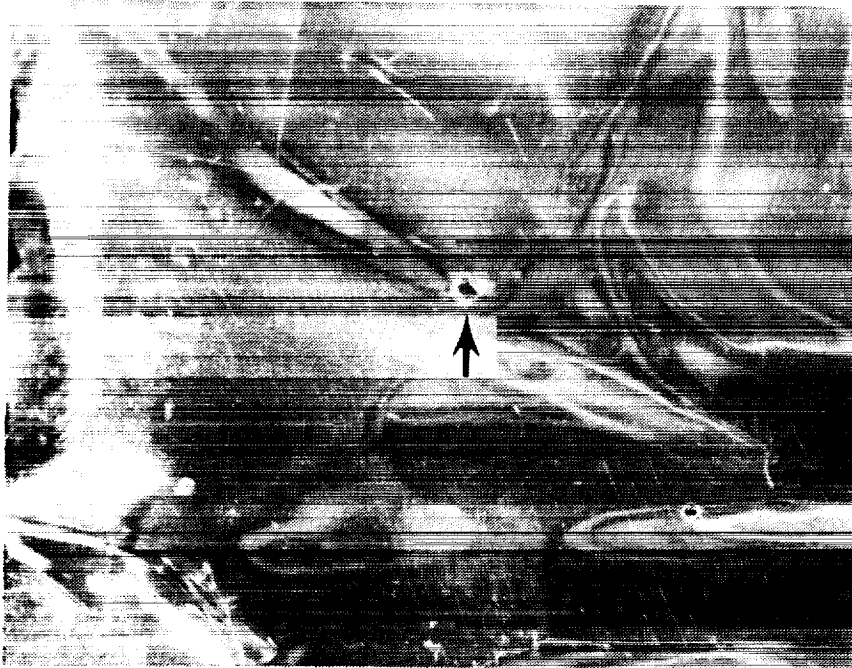
Visual examination of the thermal blanket around a Star Tracker indicated that some unknown particle had penetrated the blanket completely. In fact, it was possible to feel a slight depression in the aluminum shield for the Star Tracker and to observe with reflected light a slightly disturbed area of the black paint on the aluminum cover where the projectile had hit.

Removal of the thermal blanket permitted a closer examination of the penetration. Pictures of the front Kapton surface (Figure 10) showed a circular hole. Measurements indicated that it was an elongated hole, being 0.054 inch diameter and 0.110 inches long. The back Kapton surface also had a hole, being larger, elongated, and with a slightly torn surface (Figure 11).

Figure 10. Penetration through front side of Kapton thermal blanket which protected the Star Tracker.

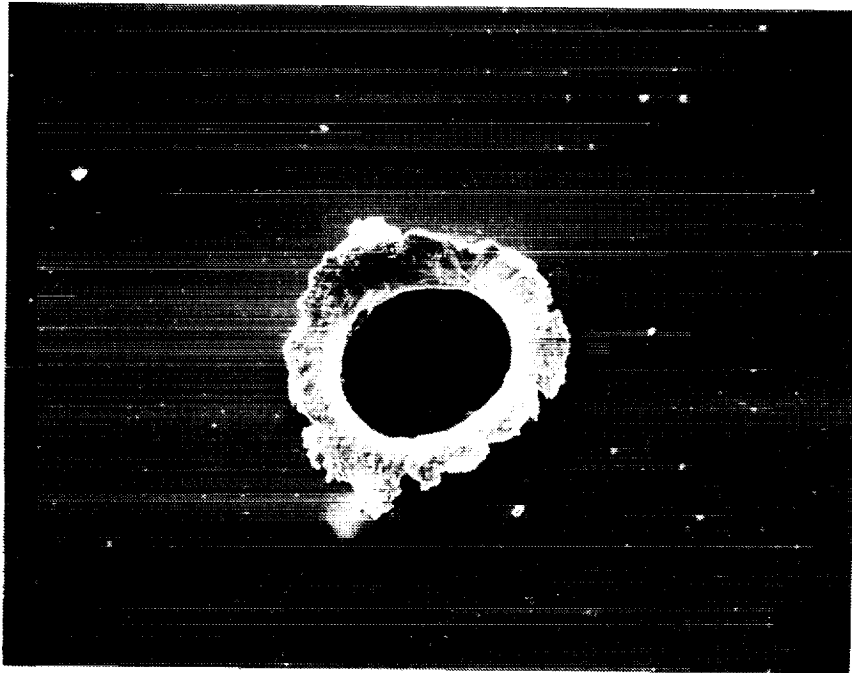
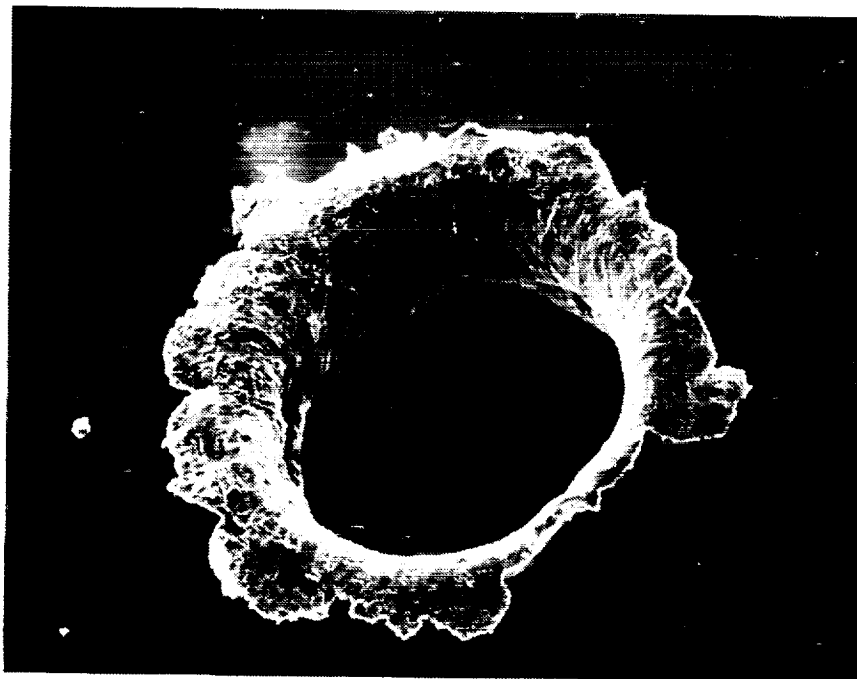
To emphasize the problems of orbital debris, examination of the thermal louvers from the ACS showed many penetrations of the thin aluminum sheet. These louvers are formed of two polished aluminum sheets, having a central spine, and being 10" long and 2" wide. Examples of the penetrations are shown in Figure 12. These penetrations were observed on at least 44 of the total of 84 louvers.

Figure 12. Penetration through 0.15 mm thick aluminum of thermal louver.

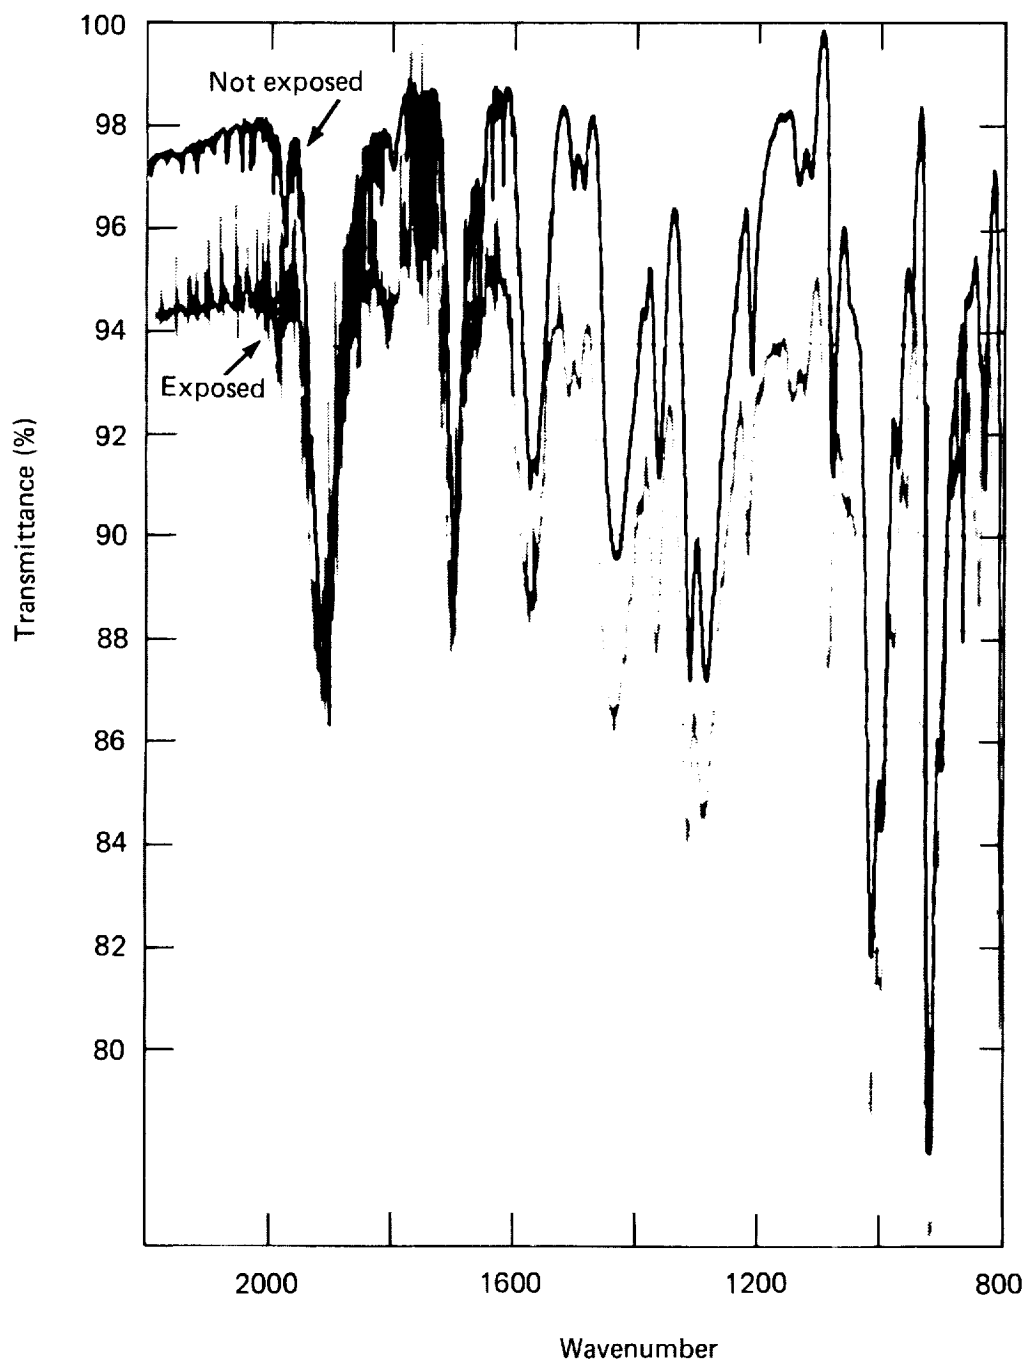
Fig. 5 Comparison of FTIR spectra of exposed and unexposed Kapton

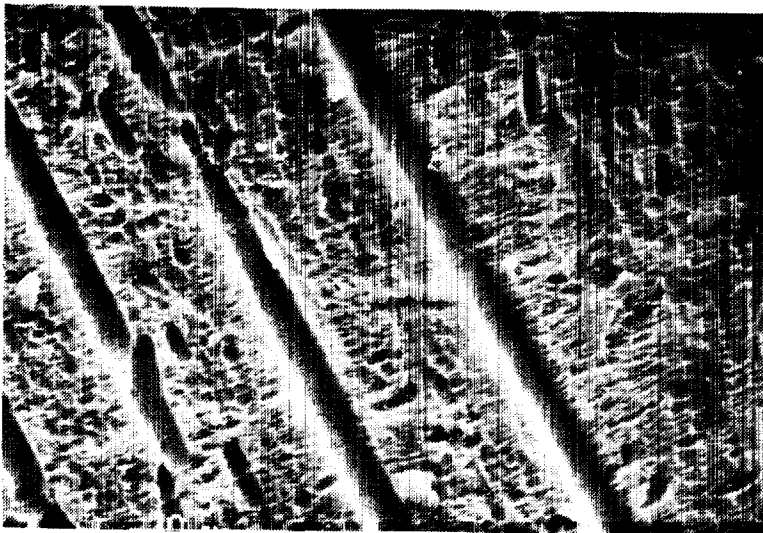
Figure 3. Kapton exposed to atomic oxygen and UV from "wiped" section (1000x).

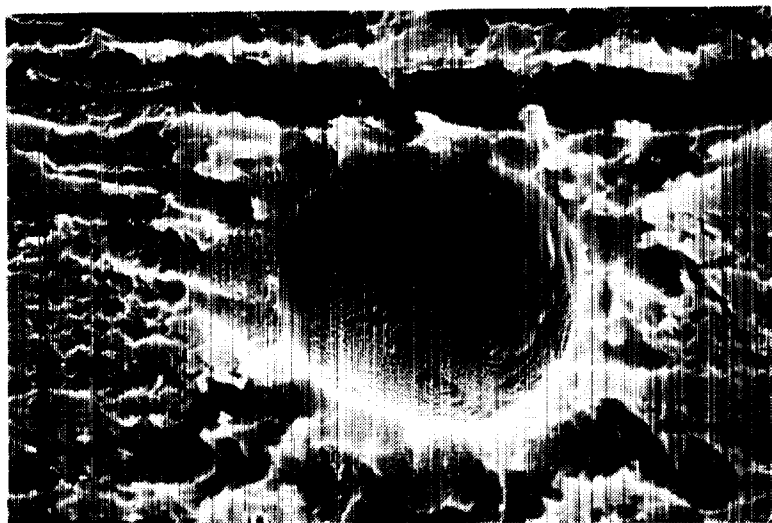
Figure 5. Kapton exposed to atomic oxygen and UV from "wiped" section showing "crater" and inner structure (2000x).

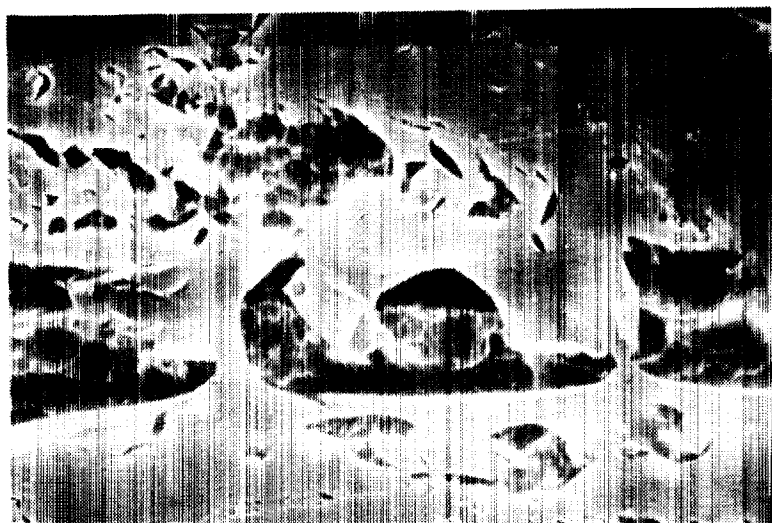
Figure 7. Kapton detail of Fig. 6 showing underlying structure (5000x).

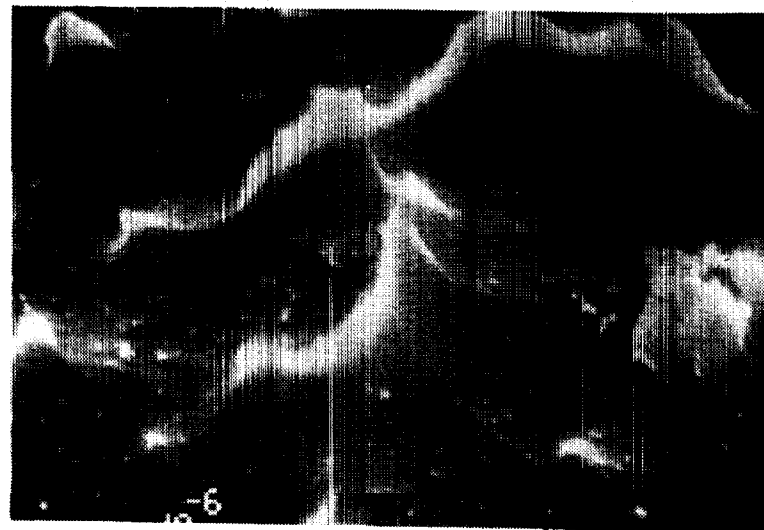
Figure 10. Detail of Kapton exposed to atomic oxygen and limited UV (10,000x).

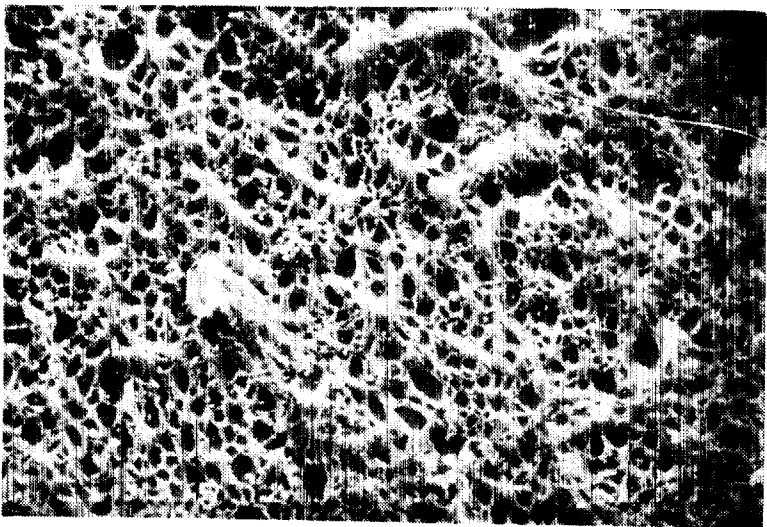
A section of Kapton located near a satellite vent hole was examined. This specimen was subjected to solar and atomic oxygen exposure. Figure 13 reveals the surface to be thoroughly covered with what was determined by EDAX (Energy Dispersive Analysis of X-rays), to be silicon. In figure 14, a detail of this contaminant is shown. Silicone potting compounds were used in the satellite, which explains the appearance of this contaminant near a vent hole.

Figure 13. Kapton surface exposed to UV showing silicon contaminant (1000x).

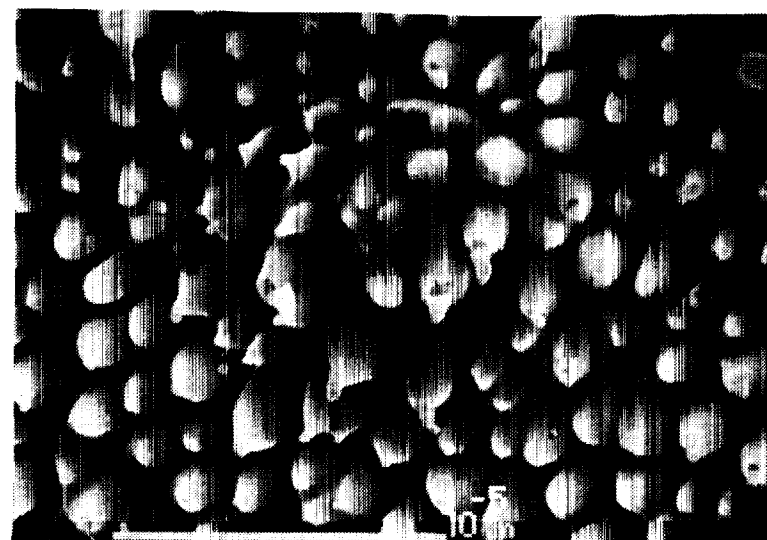
The Teflon side of the silvered Teflon sample which was exposed to both atomic oxygen and UV is shown in figure 16. A higher magnification of a typical area is shown in figure 17, which reveals the three-dimensional nature of the cones. This view is taken from as nearly perpendicular to the sample as possible. The apparent tears in the material were caused by overheating of the sample at high magnification by the electron beam of the SEM.

Figure 17. Detail of Teflon exposed to atomic oxygen and UV (5000x).

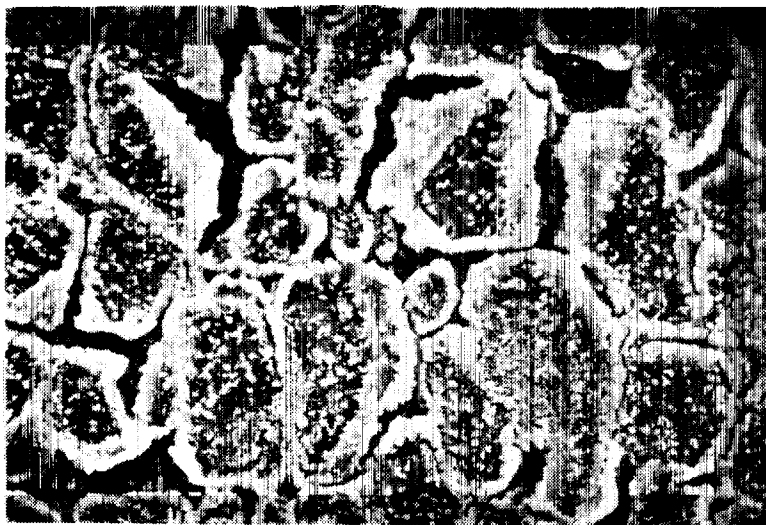
Figure 20 illustrates this concept. In figure 21, the boundaries seem to have disappeared, and the bodies themselves are now degrading. EDAX did not show any difference in composition between the boundaries and the bodies. Both areas contained silver and Inconel. Also in figure 21, the underlying Teflon is visible. In figure 22, where most of the silver is absent from the surface, Teflon has the familiar spiked appearance, as seen with Kapton on STS-8.<sup>3</sup> Figure 23 shows these structures in detail. It appears as though these spikes are generated by "peeling away" from the main bodies (see upper portion of photograph).

Figure 20. Silver surface exposed to atomic oxygen and UV, approaching silver-depleted area (1000x).

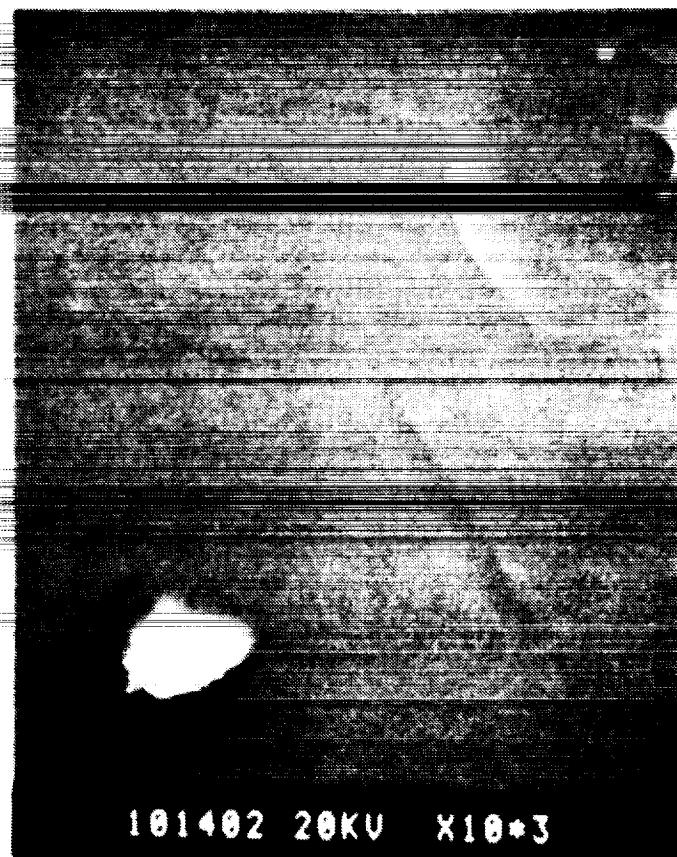
Figure 5      Kapton After 2 Hours Laboratory Exposure to Atomic Oxygen Showing  
Cusped Erosion of Surface and Fine Debris Dispersed at High  
Points on the Surface

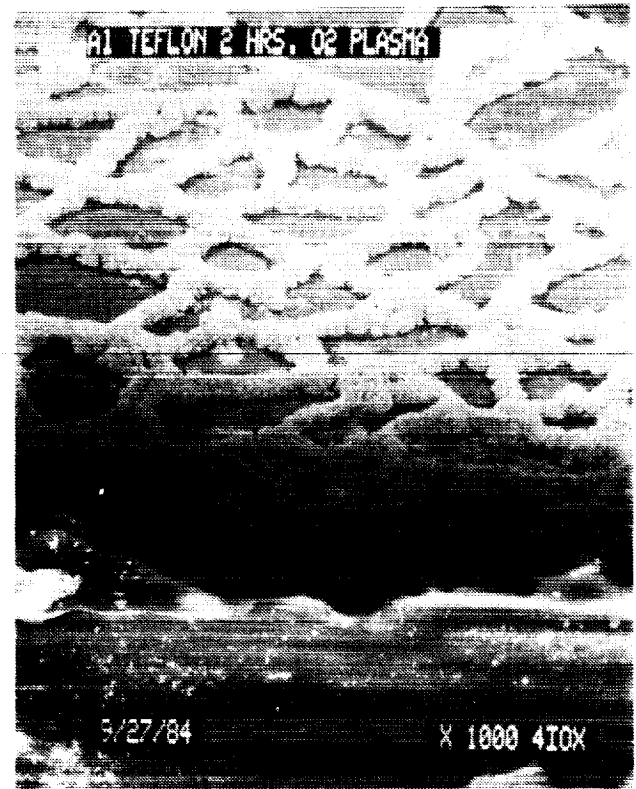
Figure 10 FEP Teflon After 2 Hours Plasma Exposure on the Ag/Inconel Surface. Growth of Ag along Grain Boundaries and Cracks in the Inconel Over Coat Has Occurred.

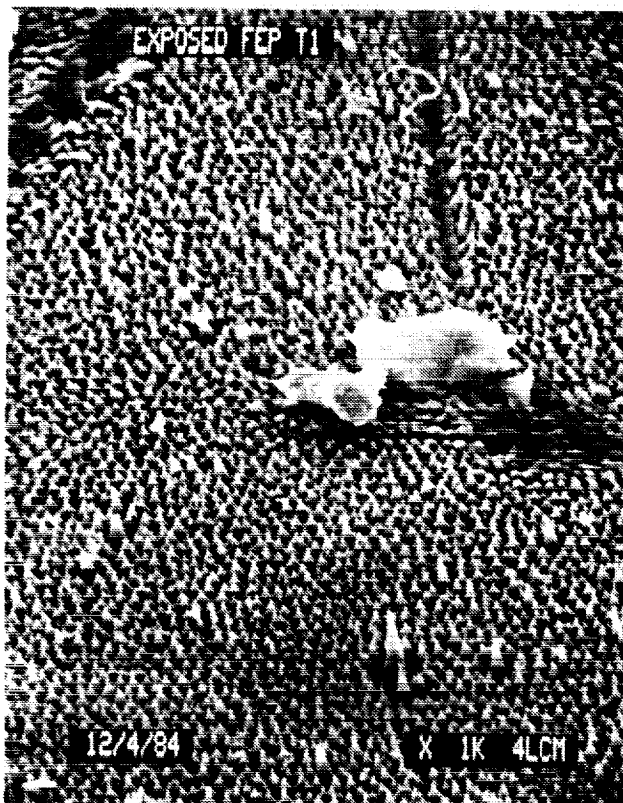
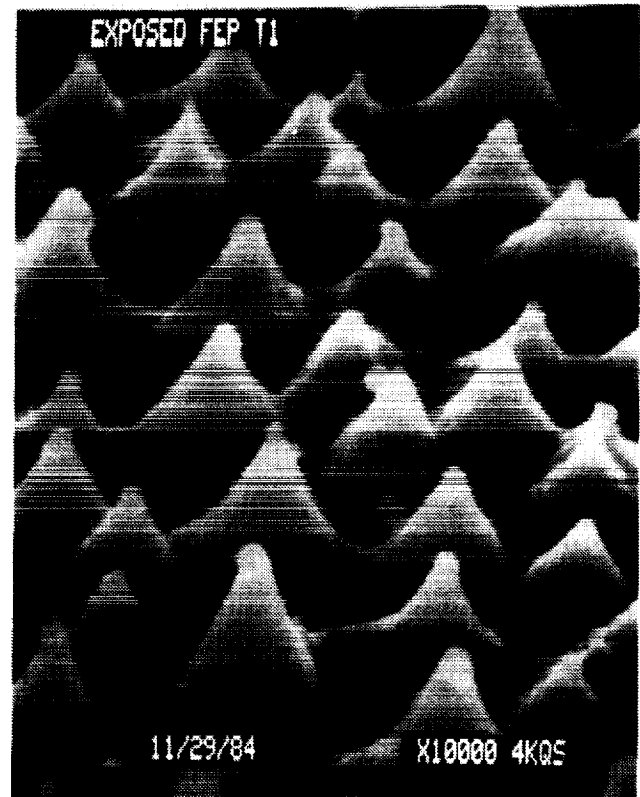
Figure 11 T1 FEP Teflon Exposed. This Specimen, Subjected to Increased Temperature and Atomic Oxygen, is Highly Eroded to Cone Texture with Rosettes of the Underlying Ag Growing through Cracks
